## 5.7. Summit, Greenland (01/20/16 – 11/23/16)

This section describes quality control of “Volume 26” solar data that were recorded by the SUV-150B spectroradiometer at Summit Station between 01/20/16 and 11/23/16. On-site support by research associates from CH2M HILL Polar Services with funding from the NSF ensured that the system was regularly calibrated and serviced during the reporting period (e.g., cleaning of irradiance collector, computer maintenance). However, there was no financial support to maintain the system otherwise, or to perform repairs.

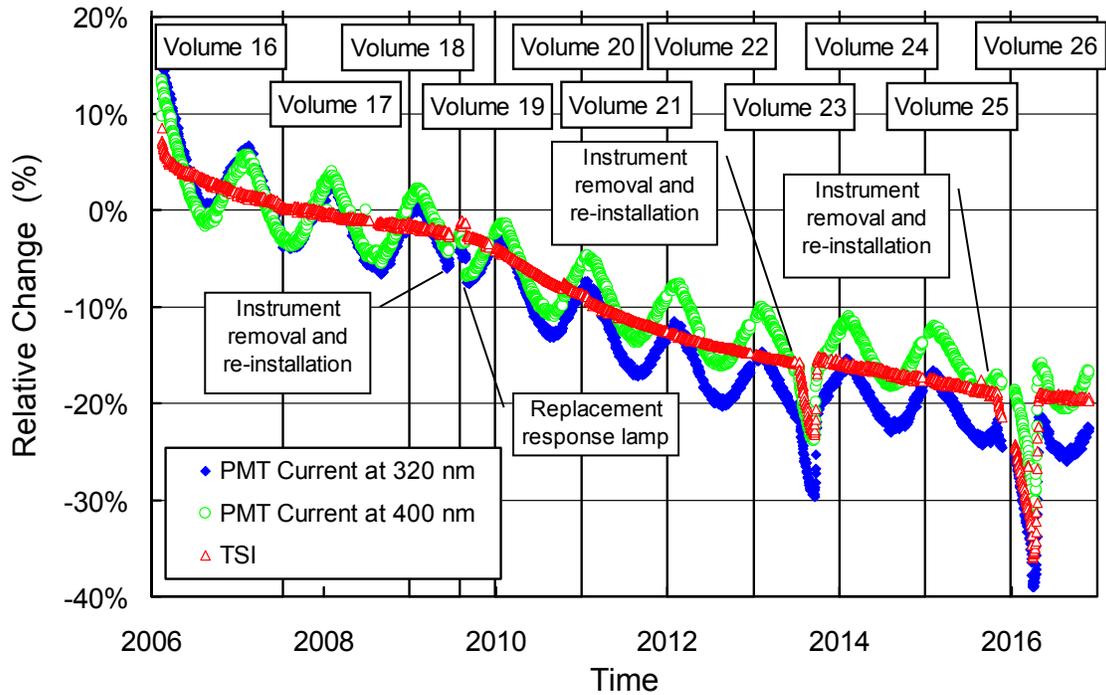
output can be decoupled from drifts in monochromator throughput or PMT sensitivity. Figure 5.7.1 shows changes in TSI readings and PMT currents at 320 and 400 nm, derived from response scans performed between 2/14/06 and 11/28/16. TSI measurements changed by about 10% between 2/14/06 and 6/20/09. The lamp failed at the end of August 2009 and was replaced. Data recorded after this time were scaled downward by a constant factor to better compare with previous measurements. The relative change of the second lamp's intensity as recorded by the TSI between 9/2/09 and 11/28/16 is similar to that of the original lamp, except of two brief periods (7/15/13 – 9/29/13 and 11/4/15 – 4/29/16). The reason for the large drift of the internal lamp during these two periods is unknown. Of note, TSI readings after 4/29/16 were stable, indicating that the lamp has recovered.

The trend of PMT currents agrees with that of the TSI measurements but there is a sinusoidal variation with a periodicity of one year superimposed on the general trend. The highest PMT sensitivity is observed in mid-February of every year, while the lowest sensitivity is observed in August. We attribute this periodicity to a long-term memory of the PMT to the radiation levels it has “seen” during the months prior to the measurement. During the period of winter darkness, the PMT becomes more sensitive, and during the summer months its sensitivity decreases. As the variation is very predictable, it can be well corrected when solar data are processed.

**Figure 5.7.1.** Time-series of TSI signal and PMT currents at 320 and 400 nm during measurements of the internal reference lamp performed at Summit between 2/15/06 and 11/28/16. Data from 9/2/10 (date of response lamp replacement) onward were scaled downward to fit into the existing pattern. Data are normalized to the period 2/14/06 - 6/20/09.

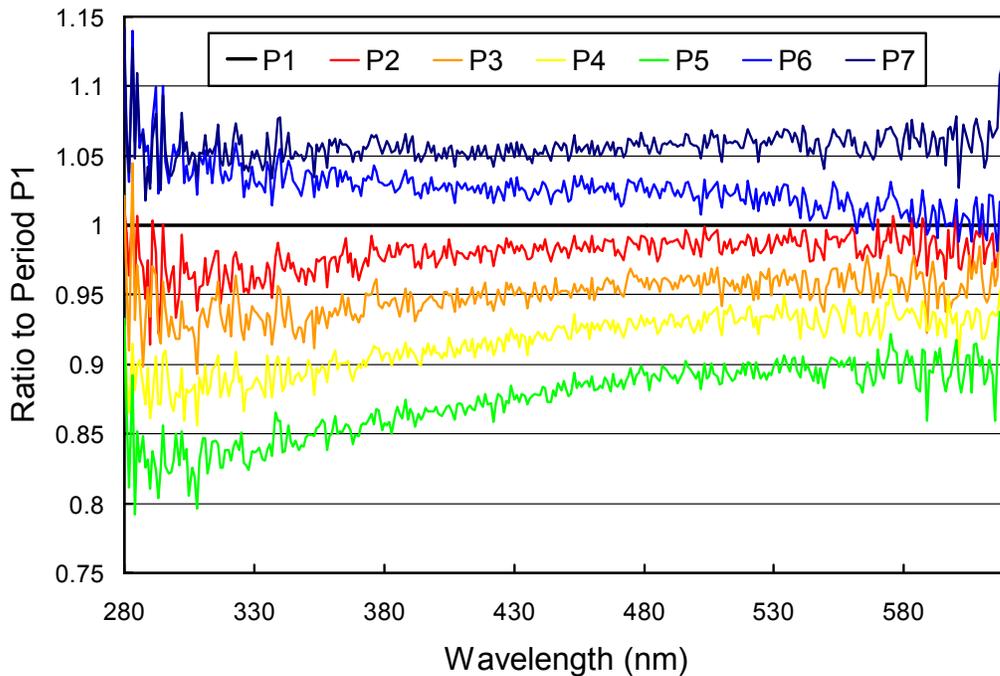
To account for the combined changes of the throughput of the system's entrance optics and PMT-sensitivity, the reporting period was broken into seven sub-periods and a different irradiance spectrum was applied to the internal lamp in each period. A summary of the calibration periods is provided in Table 5.7.1. Ratios of irradiance spectra applied in Periods P1 – P7 relative to the spectrum applied in Period P1 are shown in Figure 5.7.2. The large change in spectral irradiance between Periods P1 and P5 is due to the large decrease in the response lamp's intensity over these periods. During Periods P6 and P7, the lamp was very stable, and the two spectra for these periods are therefore in good agreement.

**Figure 5.7.2.** Ratios of irradiance assigned to the internal reference lamp in Periods P1 – P7, referenced to the irradiance of Period P1.

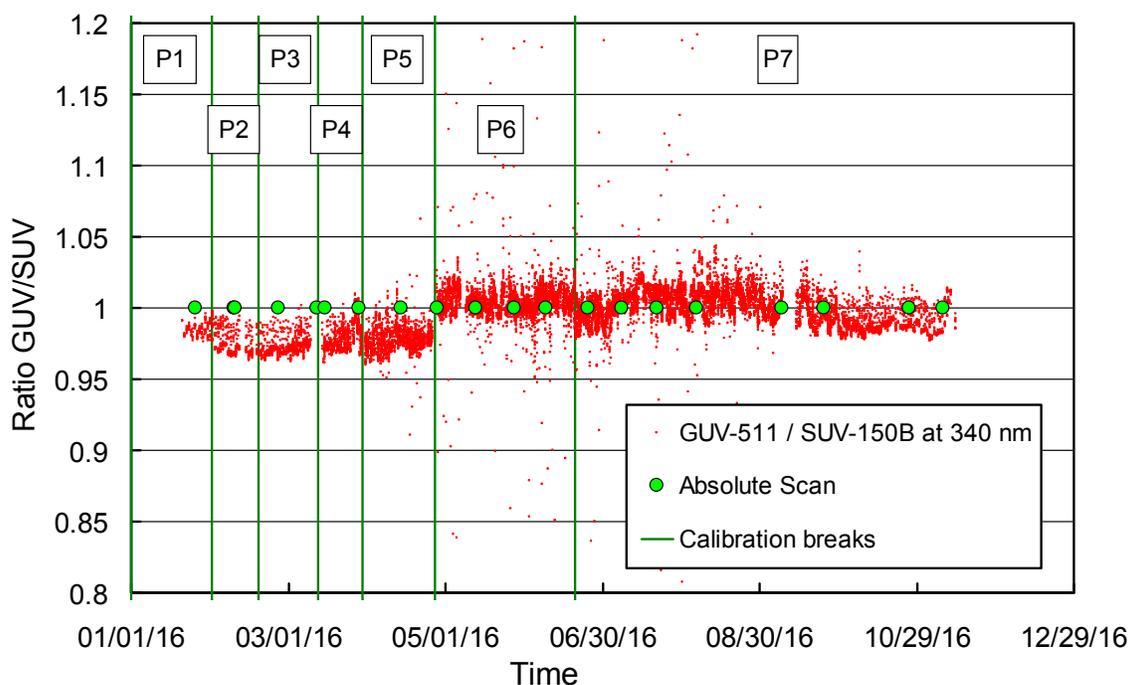
The quality of calibrated solar measurements of the SUV-150B was further assessed by comparison with data of the GUV-511 radiometer. Figure 5.7.3 shows the ratio of measurements of the GUV's 340 nm channel to measurements of the SUV-150B. The latter have been weighted with the spectral response function of the GUV's channel prior to forming the ratio. Measurements of the two instruments generally agree to within about  $\pm 3.5\%$ , with the exception of several outliers (The standard deviation of the ratio is 1.8%). Most outliers occur between June and August and are related to obstacles in the field of view of either the GUV or the SUV that shade the direct Sun. Because the two instruments are located approximately one meter apart, they are shaded at slightly different times, leading to variations in the ratio. Affected data were flagged in the Version 2 dataset of the SUV-150B.

Figure 5.7.3 also indicates a step change of 2.7% between 4/25/16 and 4/28/16. This step occurred at the time when the calibration of the system was changed from being based on lamps 200W027 and 200W038 (before 4/25/16) to being based on lamp 200W038 alone (after 4/25/16). Around this time, also the response lamp of the system regained stability. These observations may suggest that the step change is caused by uncorrected changes in sensitivity of the SUV-150B's measurements. However, comparisons of clear sky spectra with a radiative transfer model do not clearly indicate that there is a problem in the SUV-150B dataset. It can be concluded that systematic errors caused by the reliance of only one calibration lamp are less than 3%, and likely smaller.

**Figure 5.7.3.** Ratios of GUV-511 and SUV-150B measurements at 340 nm. Breaks in the calibration of SUV data and the times of absolute scans are also indicated. The apparent step change between Periods P5 and P6 is discussed in the text.

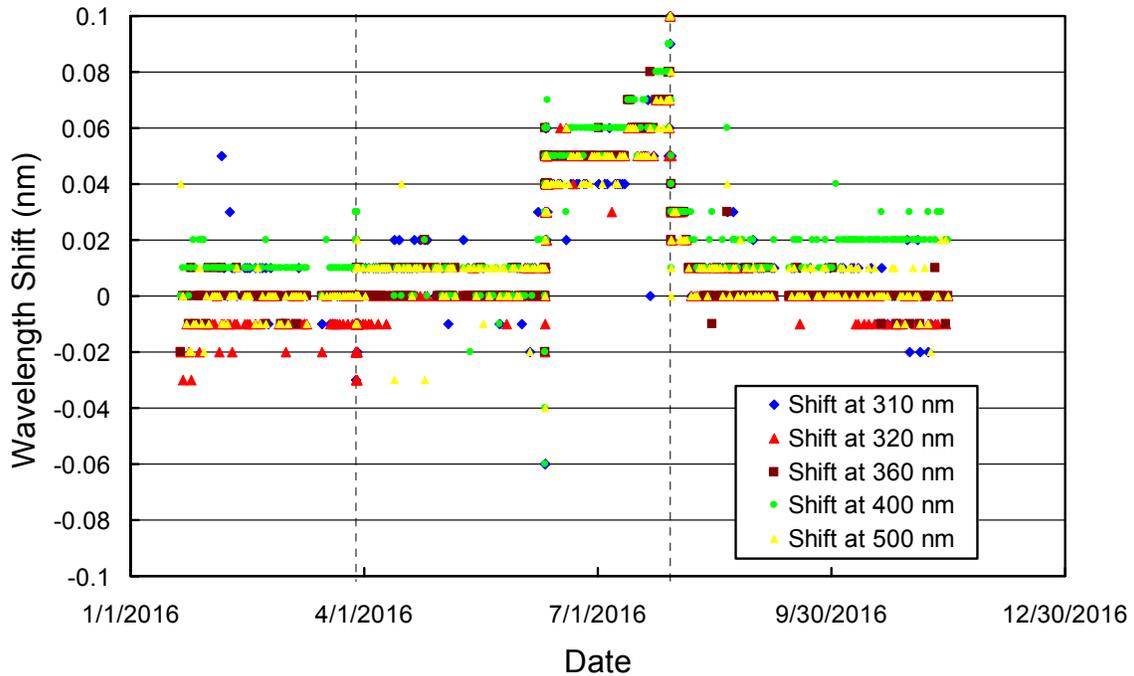
The absolute accuracy of the monochromator's wavelength registration was checked and corrected with the Fraunhofer-line correlation method developed for processing of Version 2 data (Bernhard *et al.*, 2004; see also Section 4.2.2.2). For the generation of Version 0 data, three correction functions were calculated with this method (Figure 5.7.4). After data were corrected using these functions, the wavelength accuracy of all noontime scans was verified by running the Fraunhofer-line correlation algorithm a second time, and results are shown in Figure 5.7.5. For periods 1/20/16 – 6/10/16 and 7/30/16 – 11/14/16, residual wavelength errors are smaller than  $\pm 0.03$  nm, with few exceptions. However, larger wavelength errors of up to 0.1 nm are observed for the period 6/1/16 – 7/29/16.

Figure 5.7.5. Wavelength accuracy check of “Version 0” Volume 26 data at five wavelengths in the UV and visible by means of Fraunhofer-line correlation. All noontime measurements have been evaluated. Vertical broken lines indicate times when wavelength correction functions were changed.

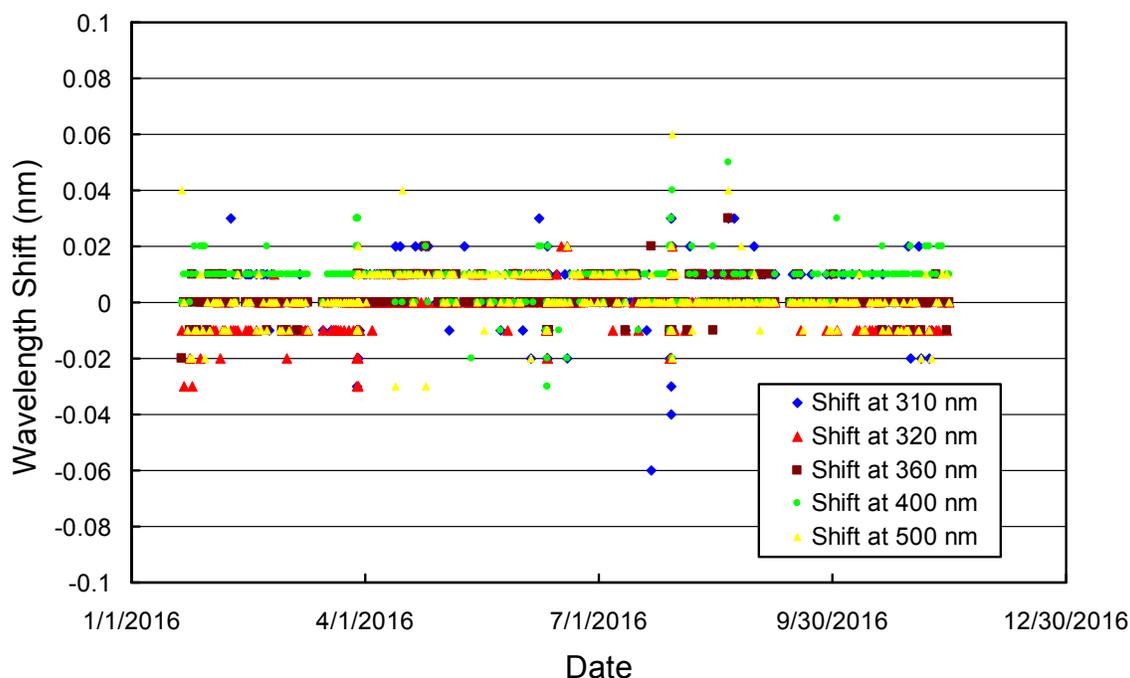
For processing of Version 2 data, the wavelength correction was further refined. As a result, residual wavelength errors of Version 2 are smaller than  $\pm 0.03$  nm throughout the reporting period, with few exceptions (Figure 5.7.6).

**Figure 5.7.6.** Wavelength accuracy check of “Version 2” Volume 26 data at five wavelengths in the UV and visible by means of Fraunhofer-line correlation. All noontime measurements have been evaluated.
